CANADIAN MOSS SOLUTIONS

ProMoss™ Treatment of Semi-Closed Loop

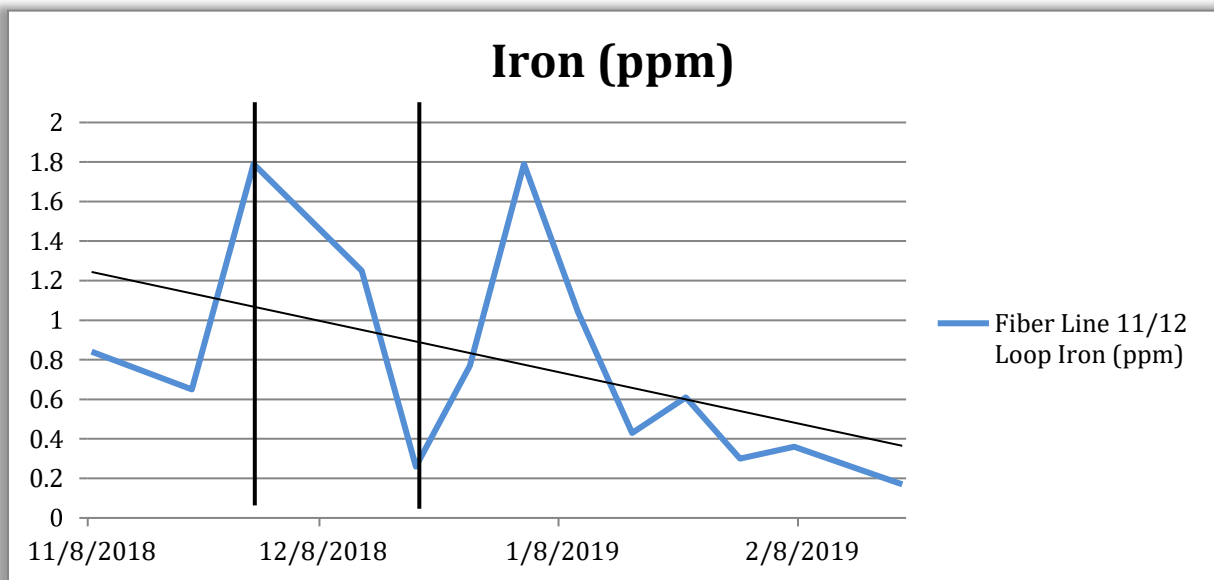
ProMoss was added to the system 8 Nov 2018. An initial spike in irons occurred and filters were changed frequently. This was a result of iron deposits and organic contamination being liberated and put into suspension. The system was flushed for two weeks which is represented by the large reduction in iron levels from early to mid-December. Iron levels continue to trend down.

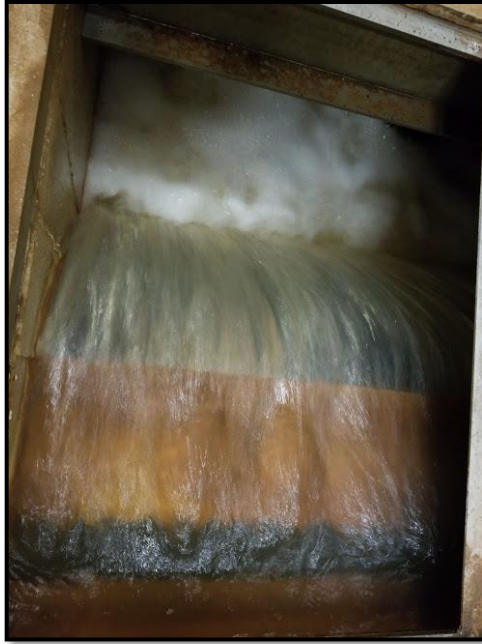
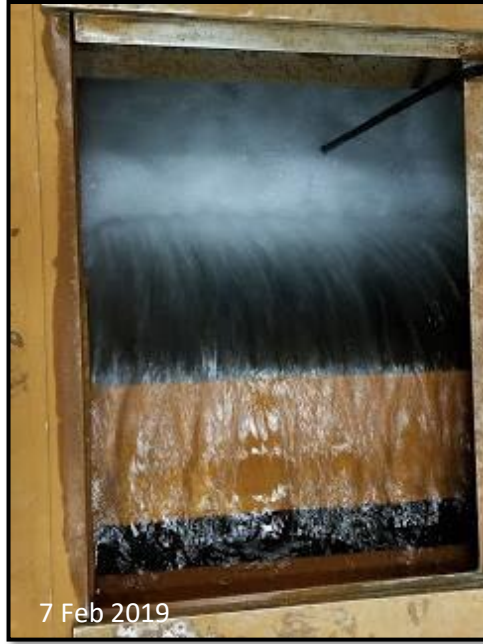
The water cleared up with reduced turbidity. Foaming likely caused by organic contamination has been nearly eliminated.

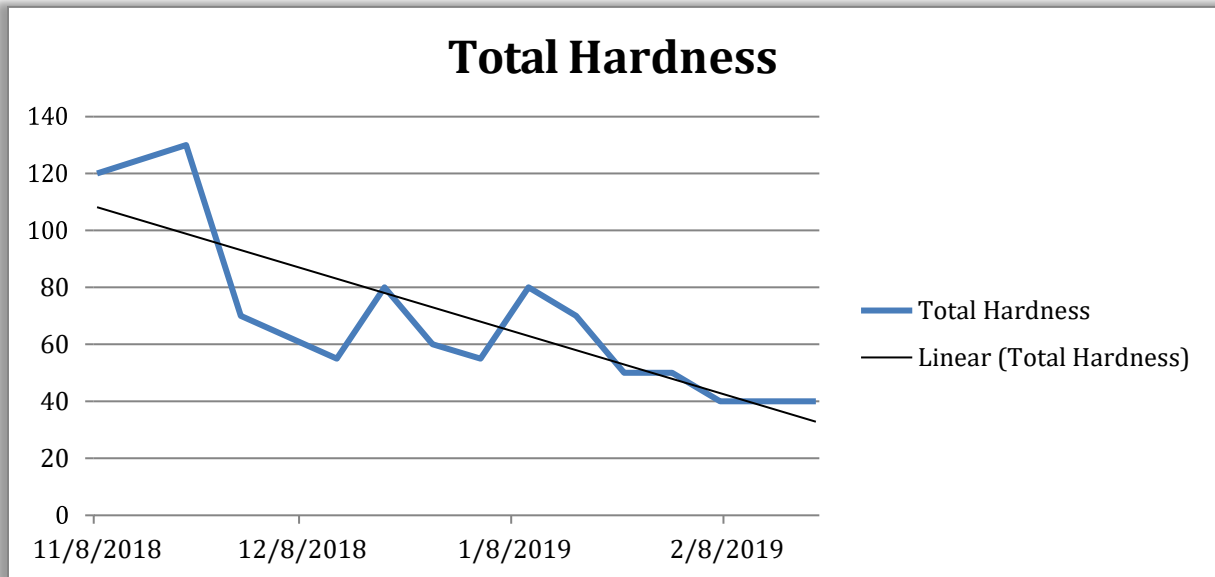
Total hardness continues to decrease with ProMoss treatment.

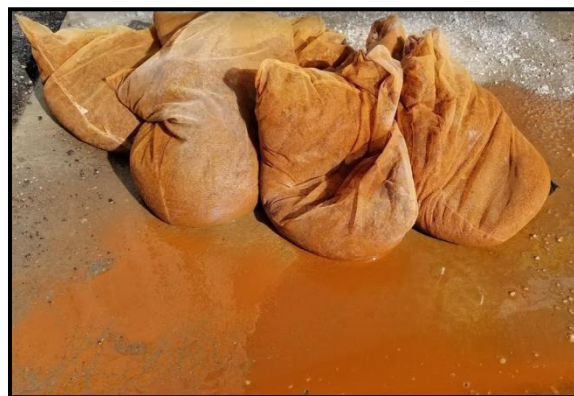
Used bags of ProMoss show the iron that has been absorbed from the loop water.
